Receptacle Adapter Ultrasonic and One-Piece Die Cast Assembly Operations

1. SCOPE

This specification covers the acceptable requirements and the not acceptable conditions for the Receptacle Adapter Ultrasonic and One-Piece Die Cast Assembly Operations.

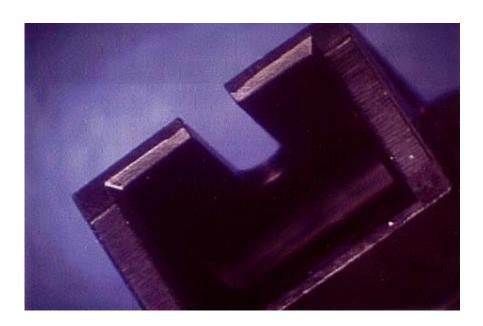
Figure 1

ACCEPTABLE

Tool Marks

NOTE

If less than 50% of the lead in chamfer has been damaged due to tool marks, the part is considered ACCEPTABLE.

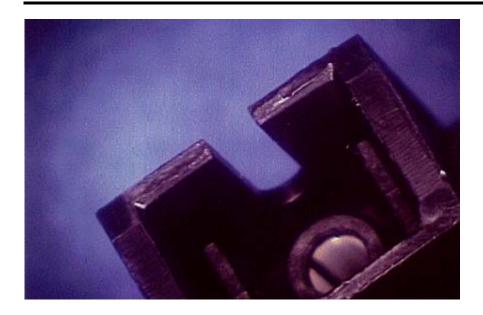
Figure 2

Tool Marks

NOTE

If 50% or more of the lead in chamfer has been damaged due to tool marks, the part is considered NOT ACCEPTABLE

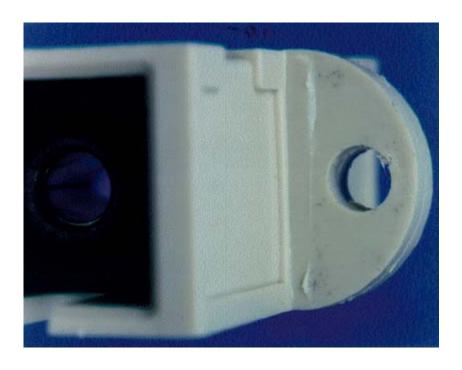
Figure 3

ACCEPTABLE

Tool Marks on Flange

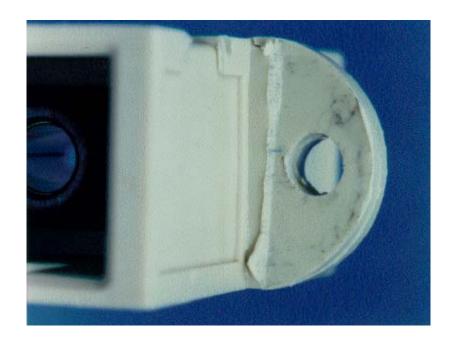
Figure 4

Tool Marks on Flange

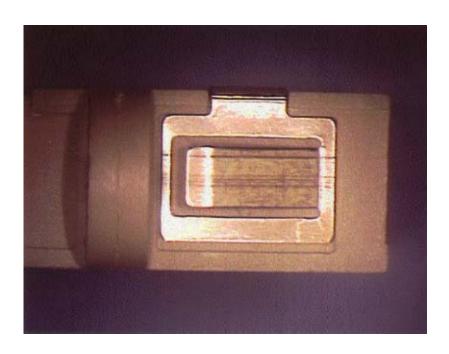
Figure 5

ACCEPTABLE

Position of Ears on Retention Clip

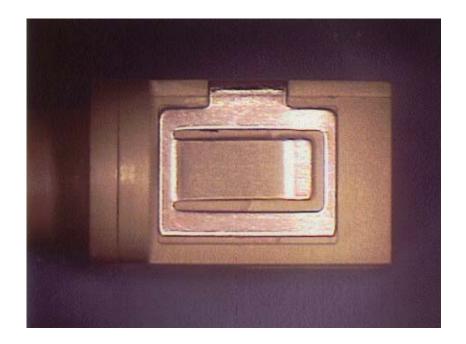
Figure 6

Position of Ears on Retention Clip

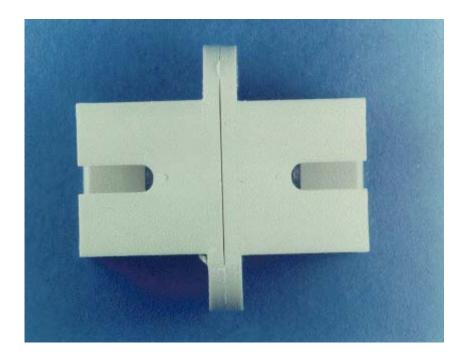
Figure 7

ACCEPTABLE

Direction of Keyway (Both in Same Direction)

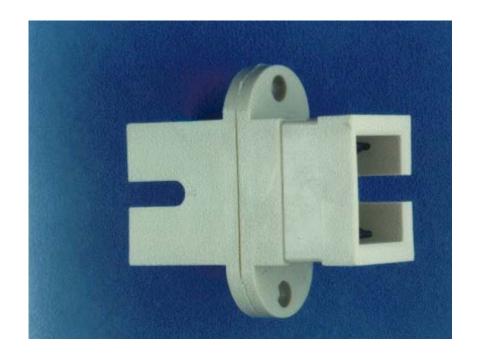
Figure 8

Direction of Keyway (One in the Front, One in the Back)

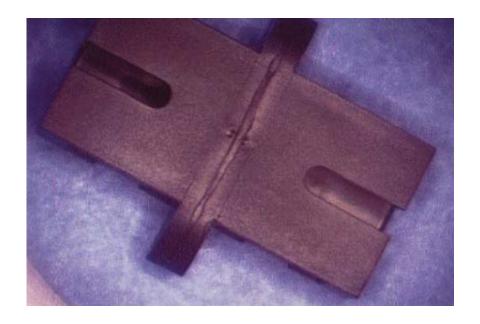
Figure 9

NOT ACCEPTABLE

Flash

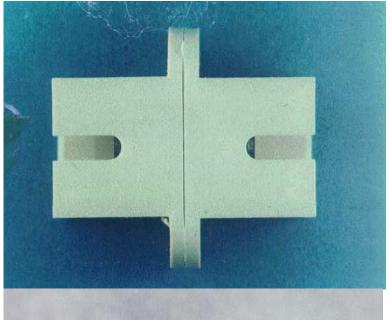
Figure 10

Allowable Gap (Up to 0.010 inch Gap is Allowed)

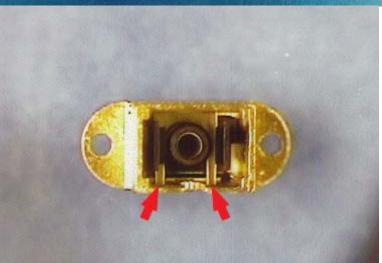
Figure 11

ACCEPTABLE

Correct Retaining Fork Placement (Viewed from the SC Side of Adapter)

The acceptable and not acceptable conditions in Figures 11 and 12 apply to both Simplex and Duplex Adapters.

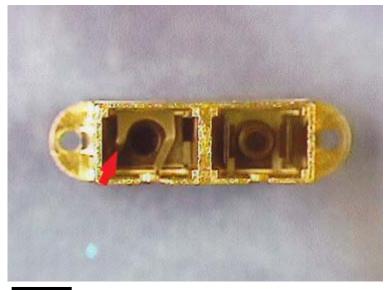
Figure 12

NOT ACCEPTABLE

Damaged Retaining Fork Placement (Viewed from the SC Side of Adapter)
